PHASE 2. HISTORIC STRUCTURES/SITES LETTER REPORT

256 Eucalyptus Hill Road
Santa Barbara, California
(APN 015-050-026)

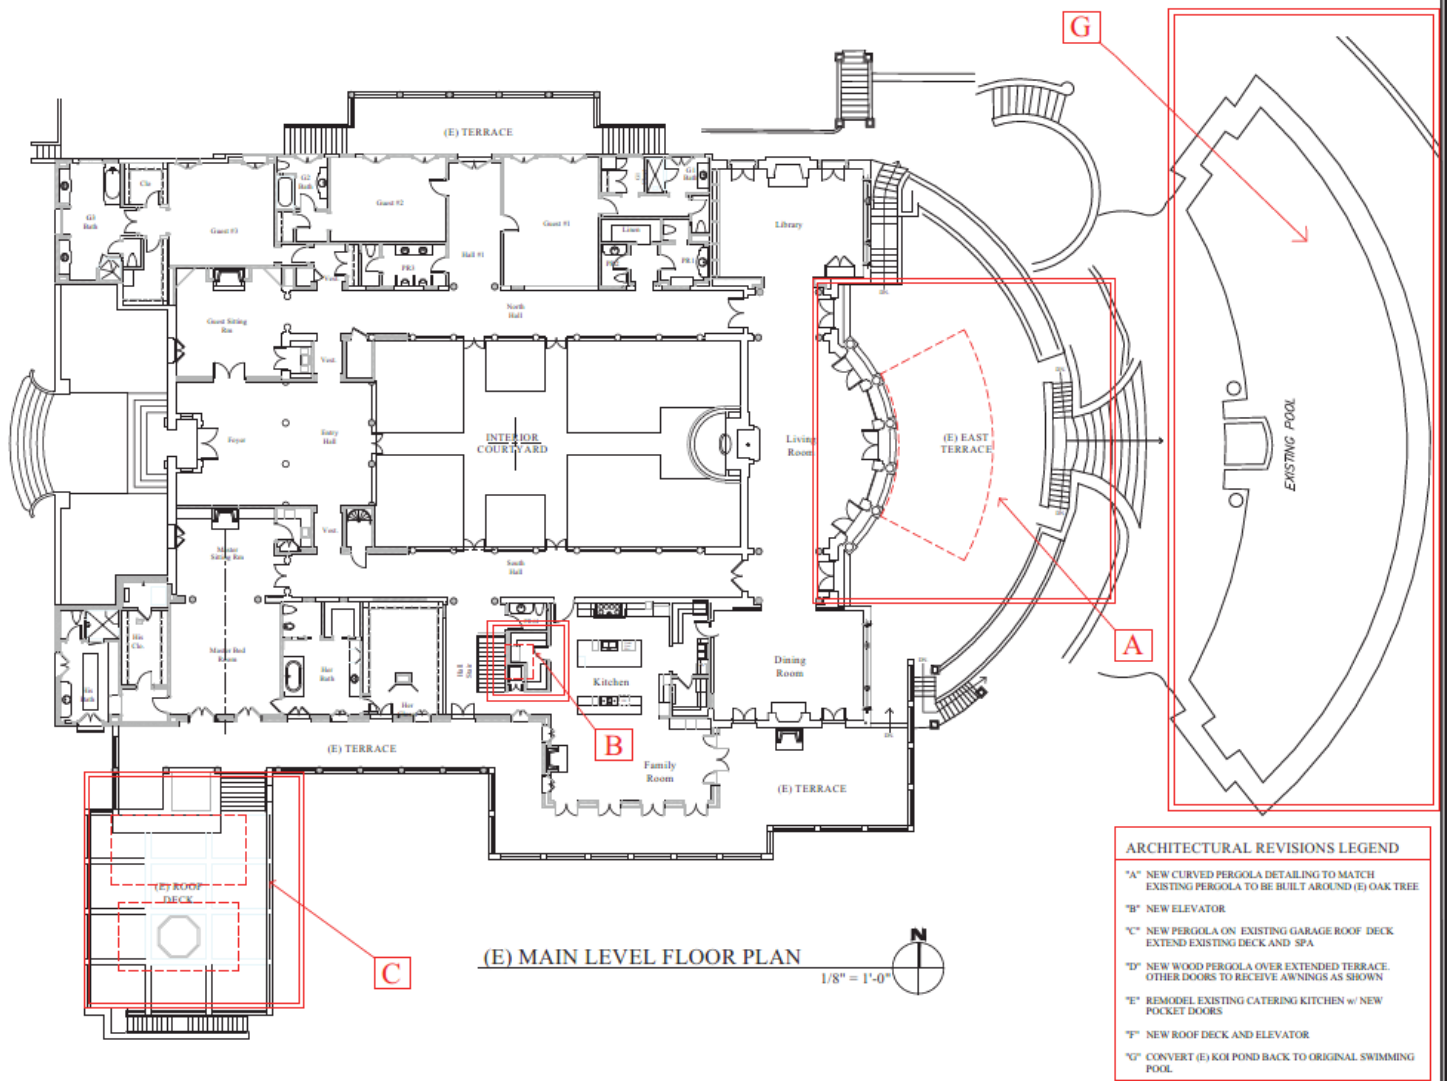
Figure 1, Partial floor plan identifying the location of proposed alterations (Sheet A-2.1)

Main Residence (Figures 1 - 1c)

Unnumbered (Figures 1 & 1a)

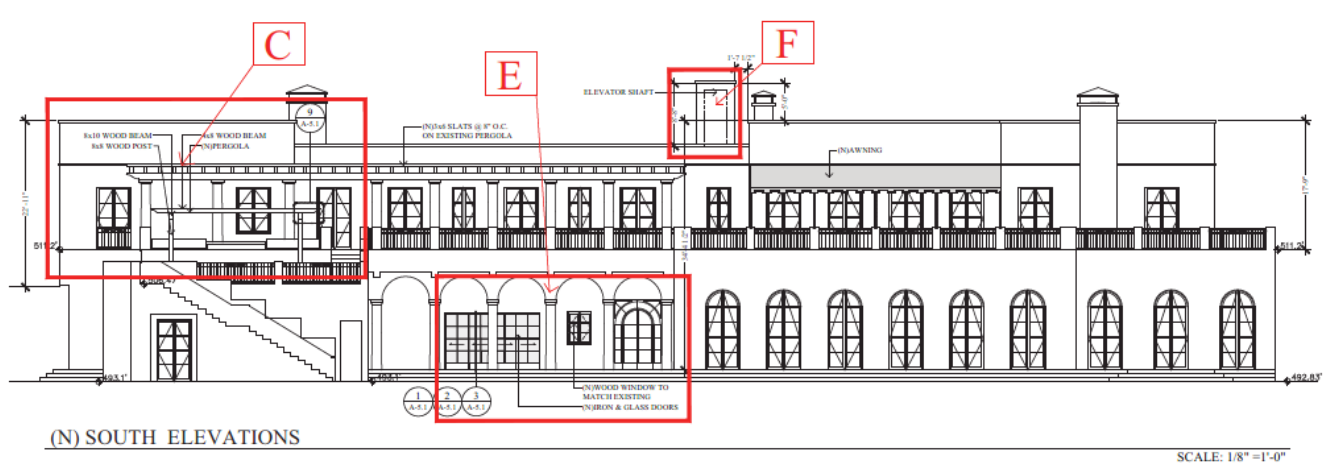
Figure 1a, South elevation identifying the location of proposed alterations (Sheet A-2.1)

1. Alter non-historic fenestration on the south elevation's ground floor by adding two glazed French doors, and a multi-light metal window would be added. The existing fenestration is not original. The proposed replacement fenestration matches the existing fenestration in design and materials. Moreover, the design of the two doors and a window is consistent with the scheme evaluated in the 2021 letter report, which met the Secretary of the Interior's Standards for Rehabilitation. Therefore, implementation of the proposed scheme for altering the south elevation's existing fenestration would not impair the resource.

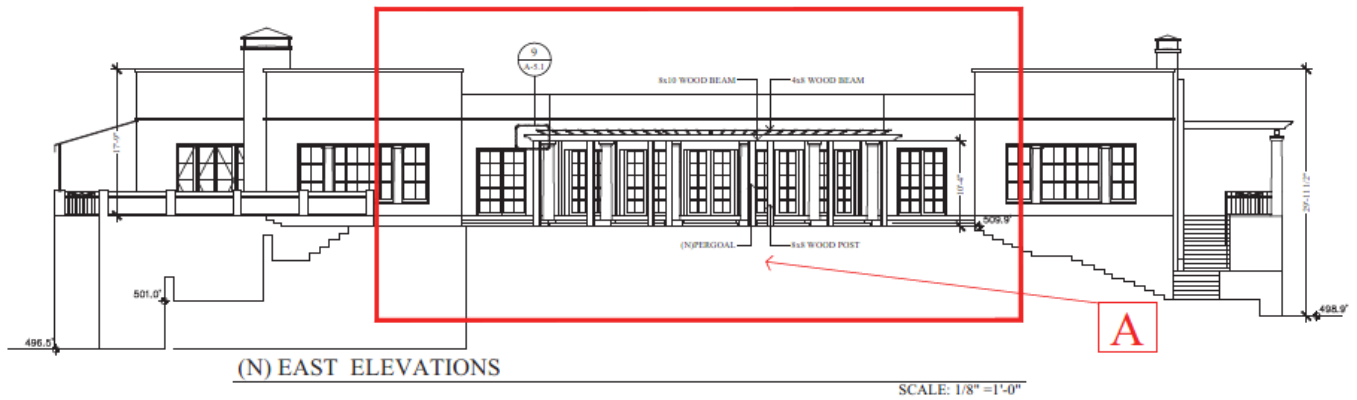
Figure 1b, East elevation identifying the location of proposed alterations (Sheet A-2.1)

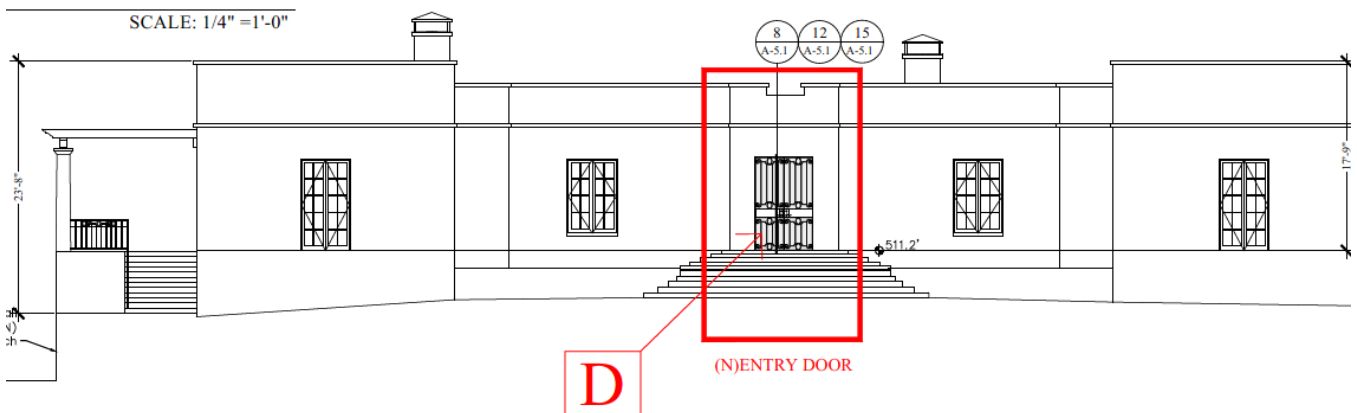
Figure 1c, West Elevation, location of the new entrance doors (Item D) on the west elevation (Sheet A-3.1)

D. Replace the existing non-historic glazed metal front doors on the west elevation with a new set of glazed metal doors. The new doors emulate the existing doors in overall design and materials. Replacement of the non-historic glazed doors with a new set of doors designed to emulate design features of early 20th century doors would not remove design features or materials that contribute to the building's historic or architectural significance. Therefore, replacing the existing non-historic doors would not impair the resource.

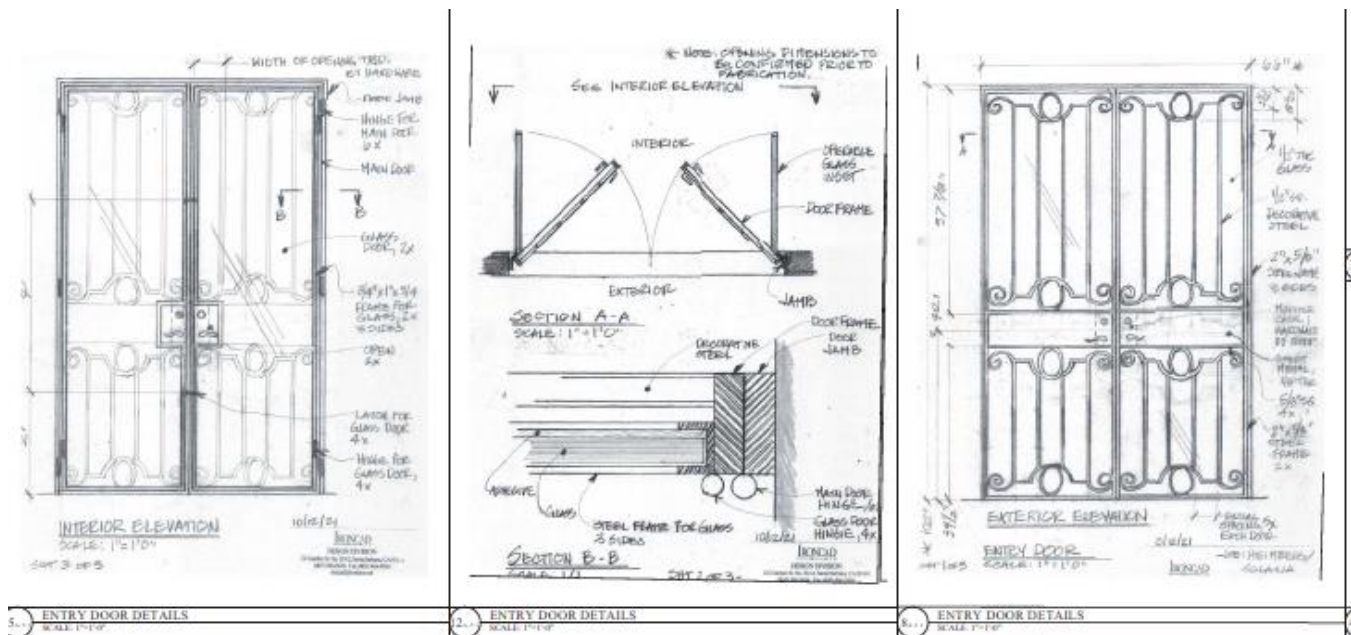
Figure 2, Proposed design for the new entrance doors on the west elevation (Sheet A-3.1)

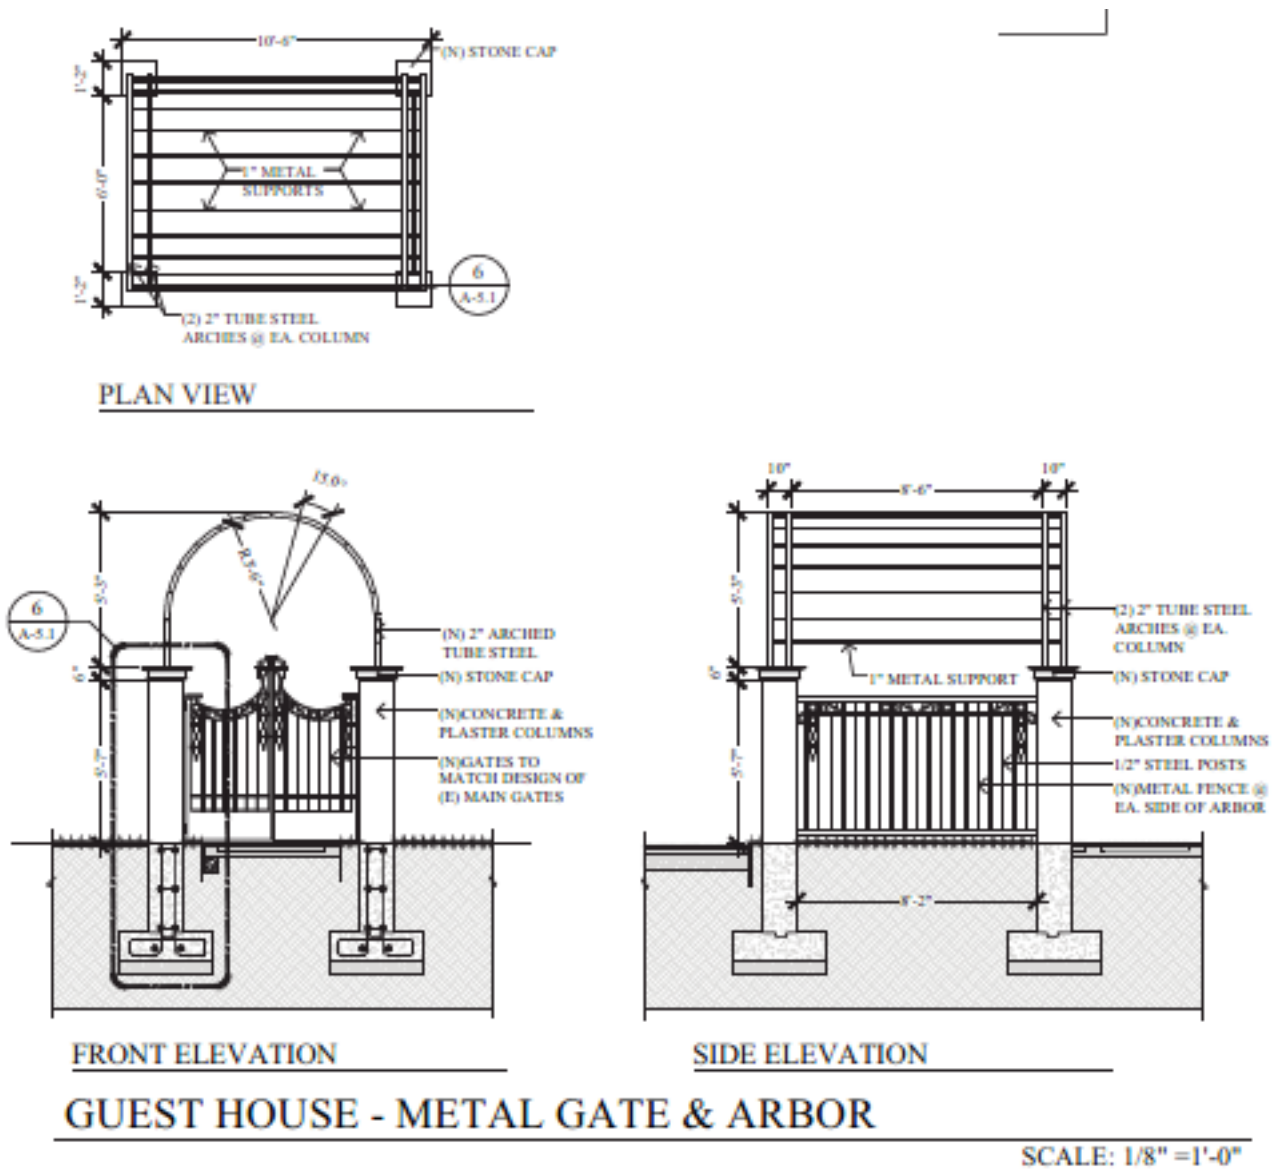
Figure 3, Proposed design for a gate and pergola for the guesthouse (Sheet A-3.1)

Guesthouse (Figures 1 & 3)

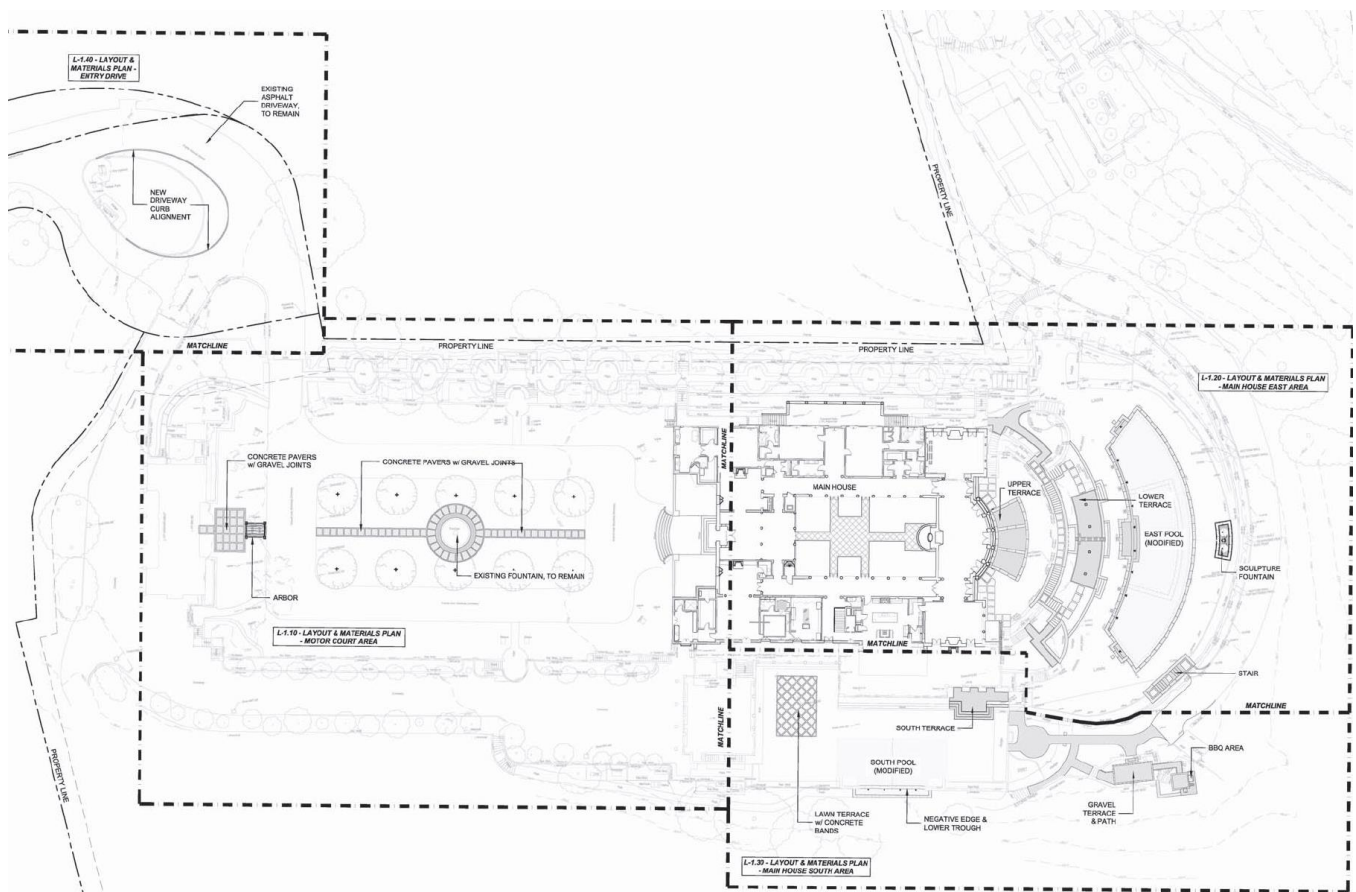
Figure 4, Site plan for alterations to the hardscape (L 1.00)

Landscape and Hardscape (Figure 4)

2. The design of the motor court's hardscape and plantings has been finalized. Proposed materials such as stone pavers and concrete are consistent with the main residence's original construction materials and the landscape and hardscape features added during the 1999 renovation. Moreover, refinements to the design of the motor court are consistent with the scheme evaluated in the 2021 letter report, which met the Secretary of the Interior's Standards for Rehabilitation. Therefore, implementation of the proposed scheme for the motor court would not impair the resource.

3. Refinements to the design of the south terrace, barbeque area, terraces, steps, and pathways are consistent in materials and design, with the original main residence and hardscape and the 1999 remodeling project. Moreover, refinements to the design barbeque area and its setting are consistent with the scheme evaluated in the 2021 letter report, which met the Secretary of the Interior's Standards for Rehabilitation. Therefore, implementation of the plan for this area of the property would not impair the resource.
